**International Forestry**

**TREE PLAN FOR GLENEALY COURT  
SHORT PLAT  
11240 AND 11406 NE 112<sup>TH</sup> STREET  
KIRKLAND, WASHINGTON**

July 16, 2007

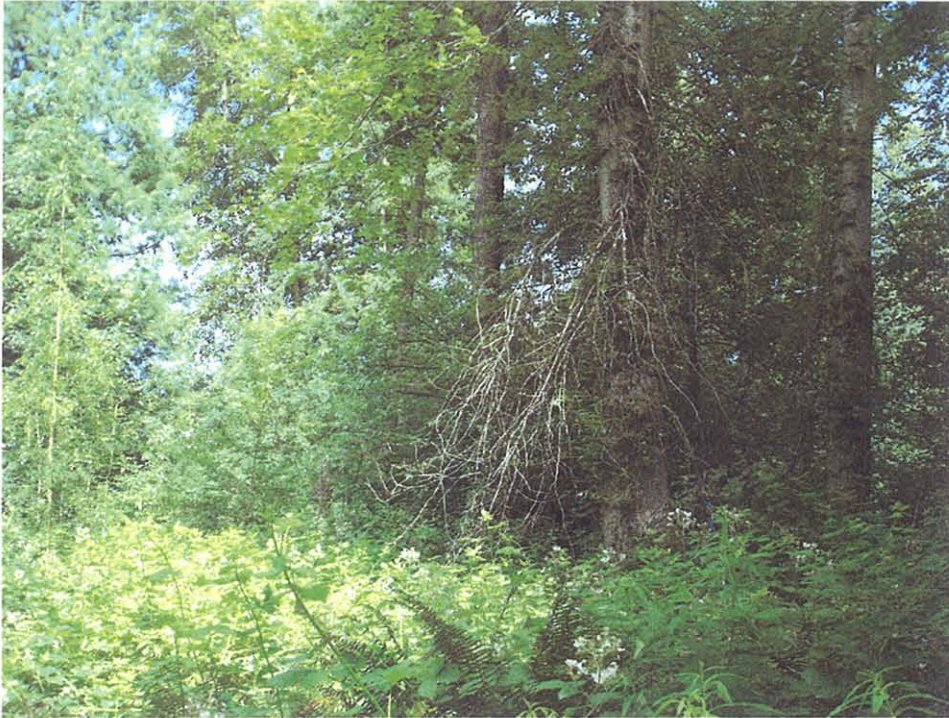
Delineated wetland in northeast corner-comprised of black cottonwood

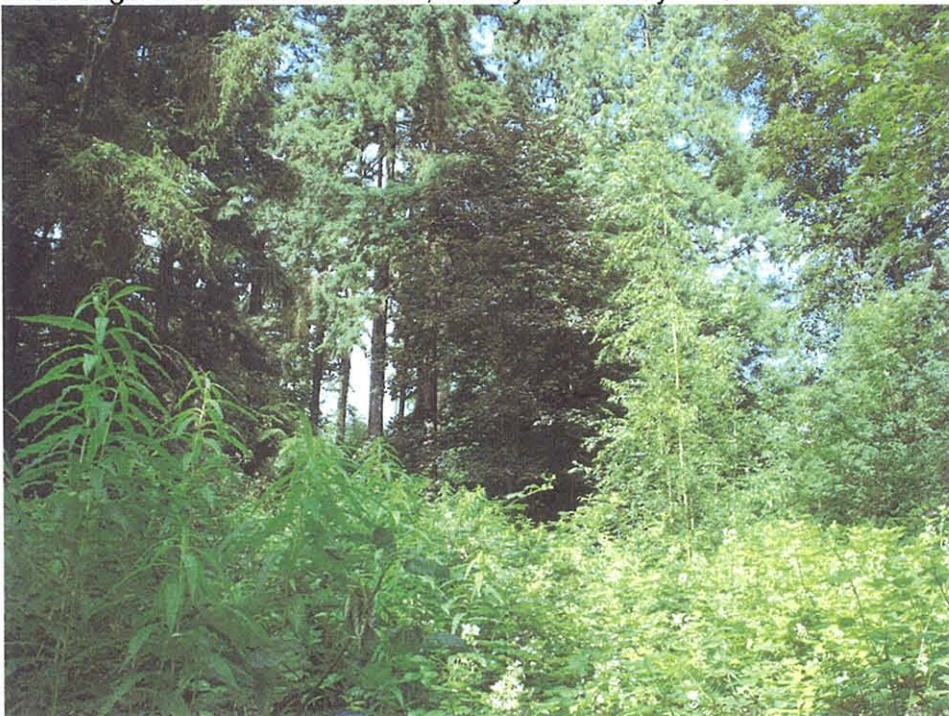
West edge of delineated wetland, mostly blackberry

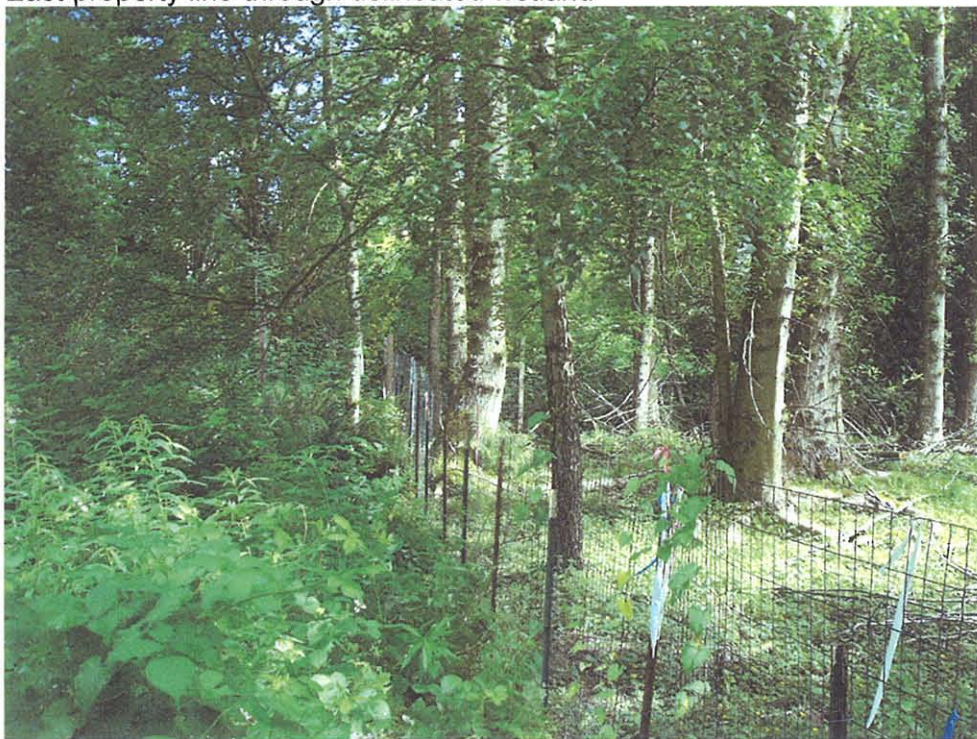
East property line-through delineated wetland

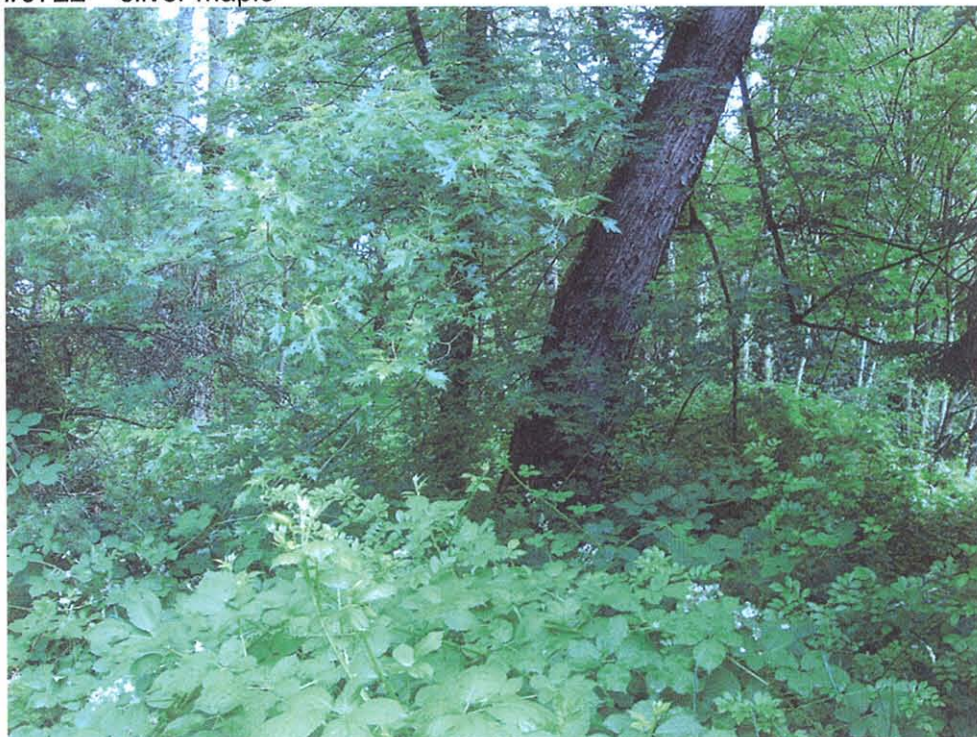
#9722 – silver maple

Tree #9722 is a mature silver maple with a very large crown spread. The majority of the crown extends far to the east and onto neighboring property. Crown reduction thinning, specifically on this east side is recommended to make the crown more uniform, and to reduce the risk of large branch failures.

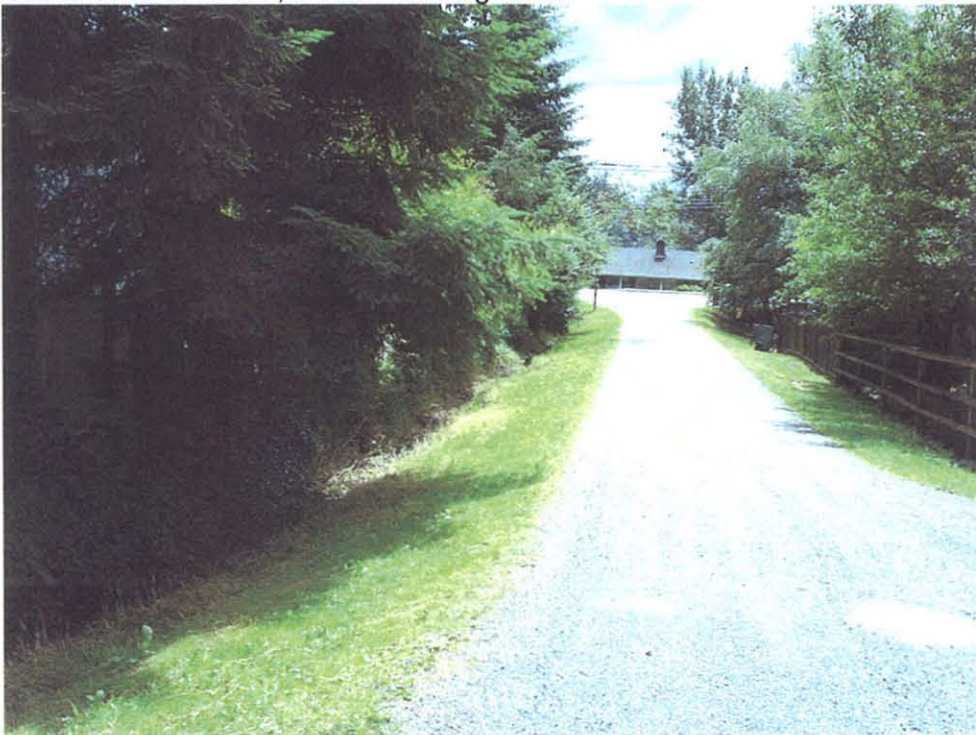
Gravel road to Lots 1, 2 and 3 looking south

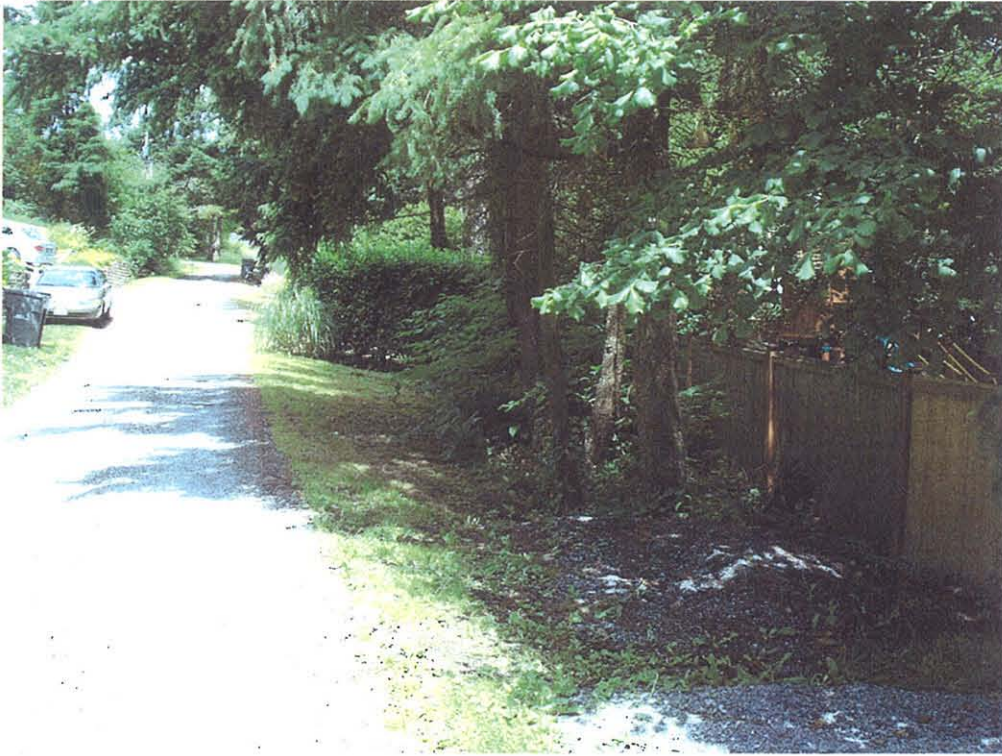
Gravel road to Lots 1, 2 and 3 looking north

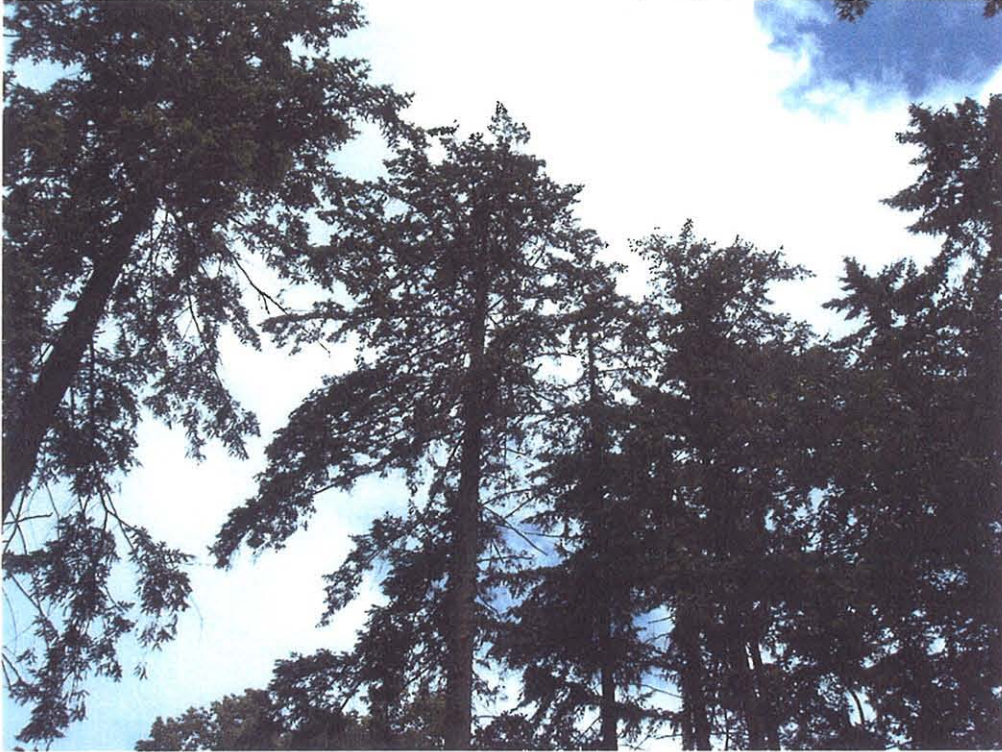
Trees on proposed Lots 6 and 7-two in middle of photo suspected of root disease infection

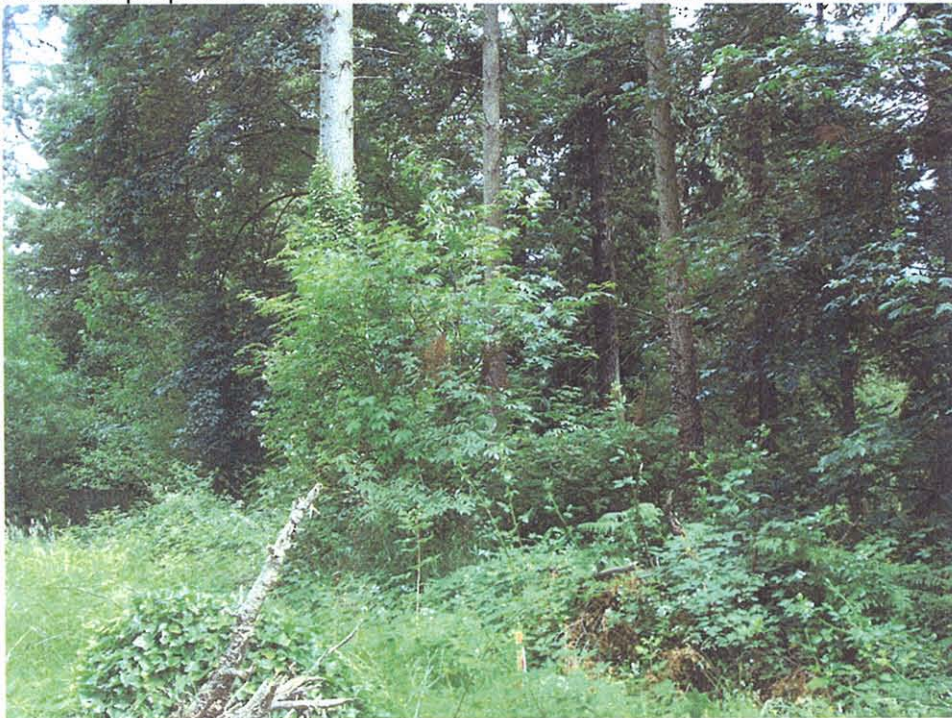
Between proposed Lots 6 and 7- several root-diseased trees windthrown in this area
